### **Preservation and planting of trees on dams and dykes**

#### **Conflicts - Solutions - Implementation**

# Rehabilitation of dams with preservation of the tree population using the example of a Stör waterway

# Reconstruction of dykes with preservation of the tree population using the example of the Rhine dyke in Neuss

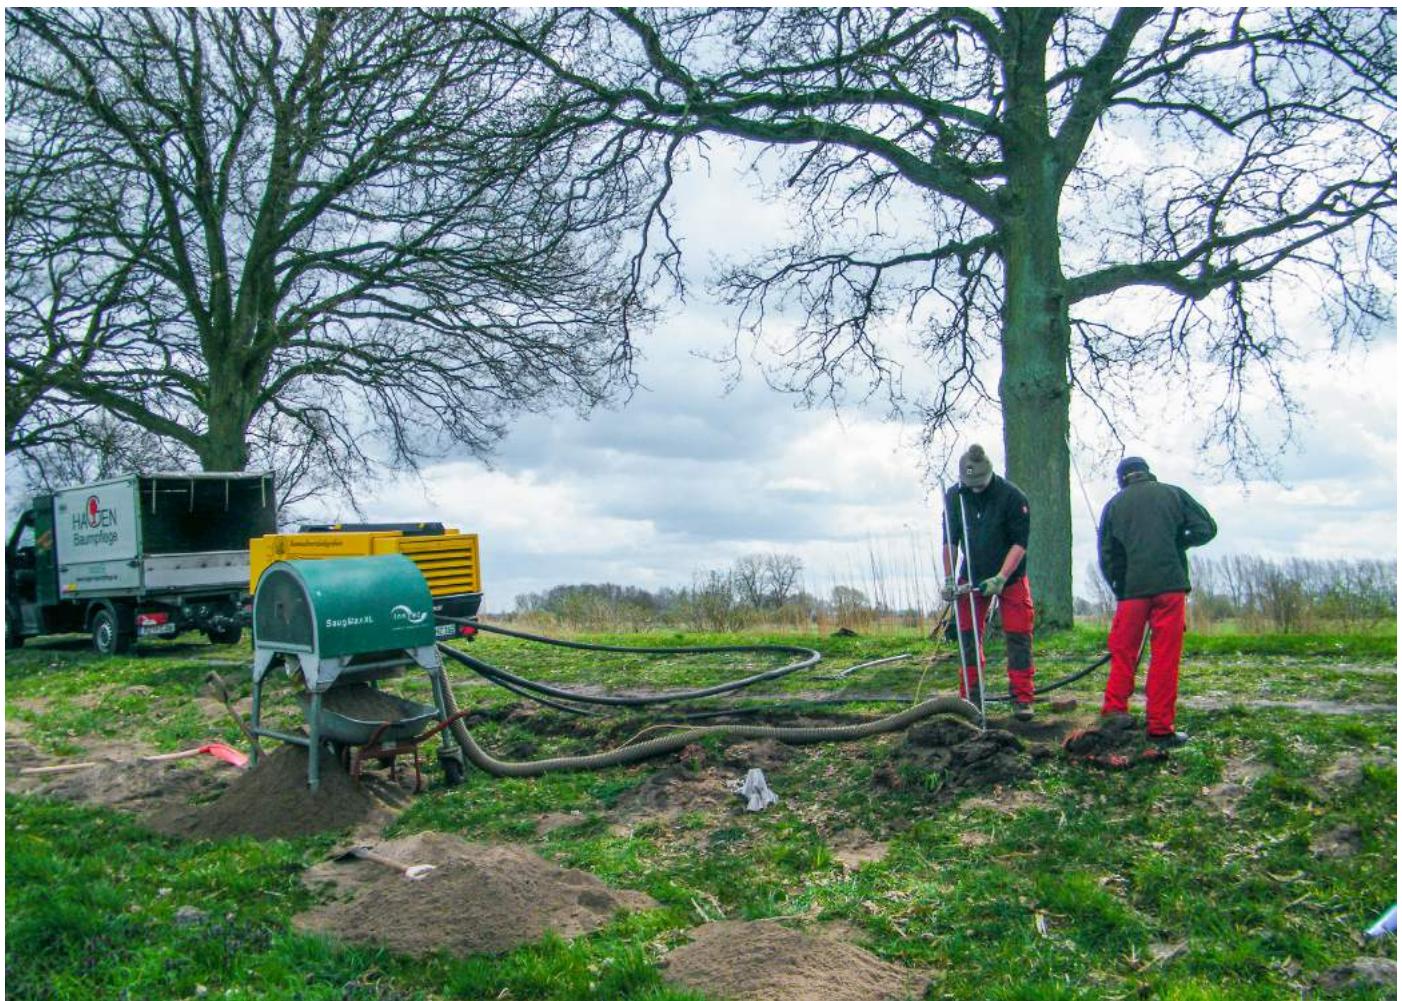
PHOTO Suction unit in use.

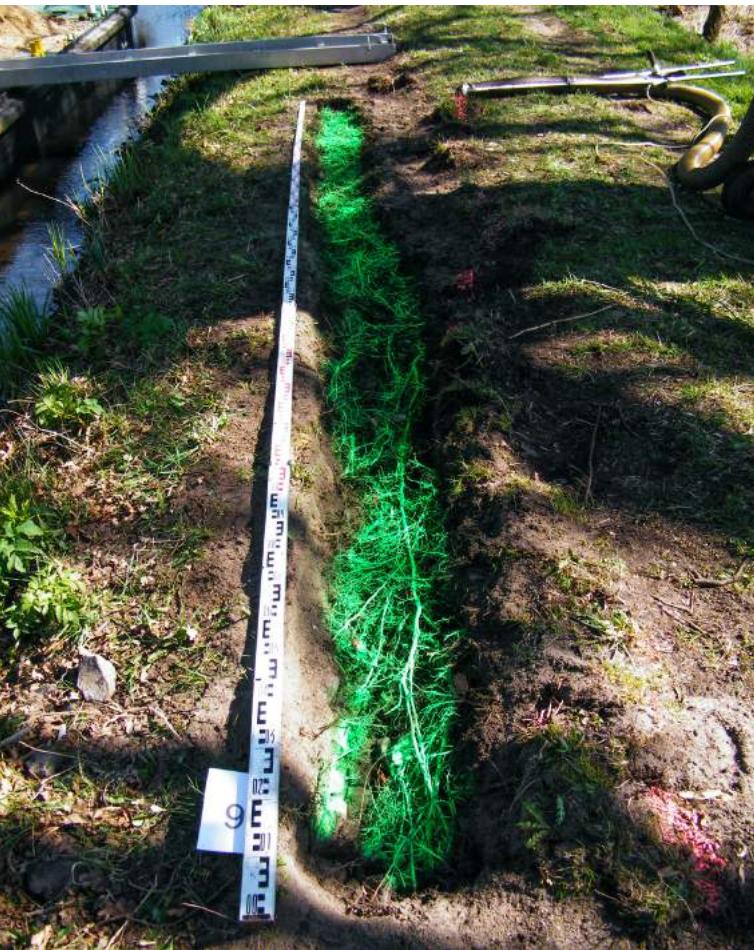
PHOTO Example root search excavation right bank Stör-Canal.

The exposed roots were dyed with a chalk spray for better photographic documentation. A measuring stick serves to clarify the proportions.

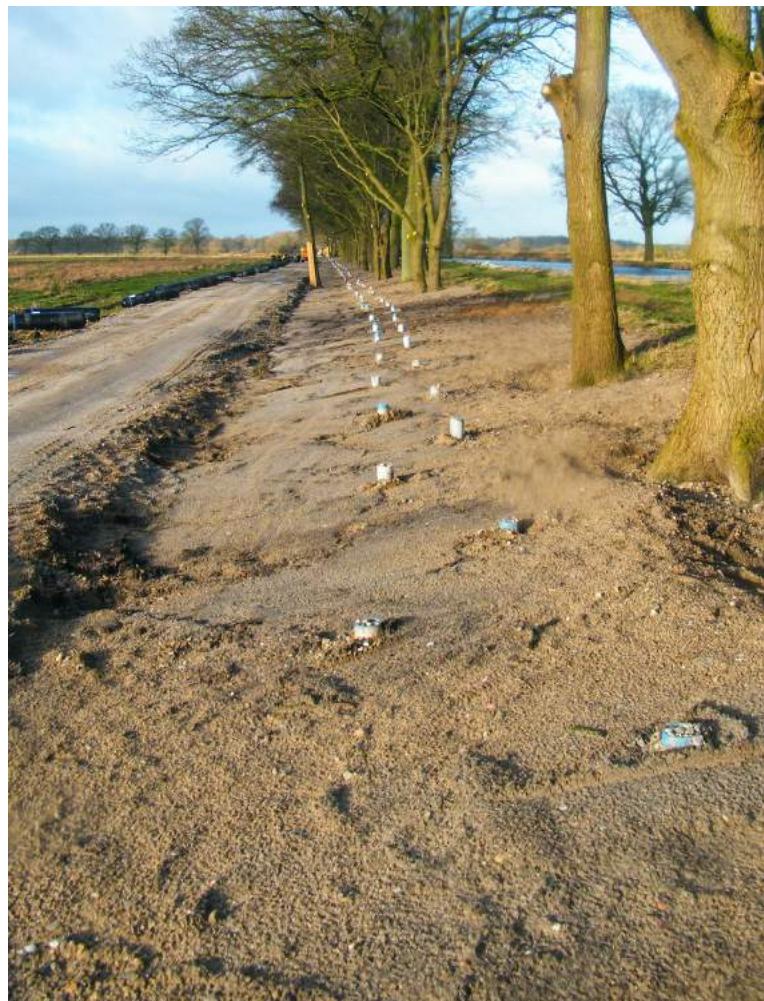
PHOTO View of the filling with built-in tree ventilators, on the left the temporary construction road.

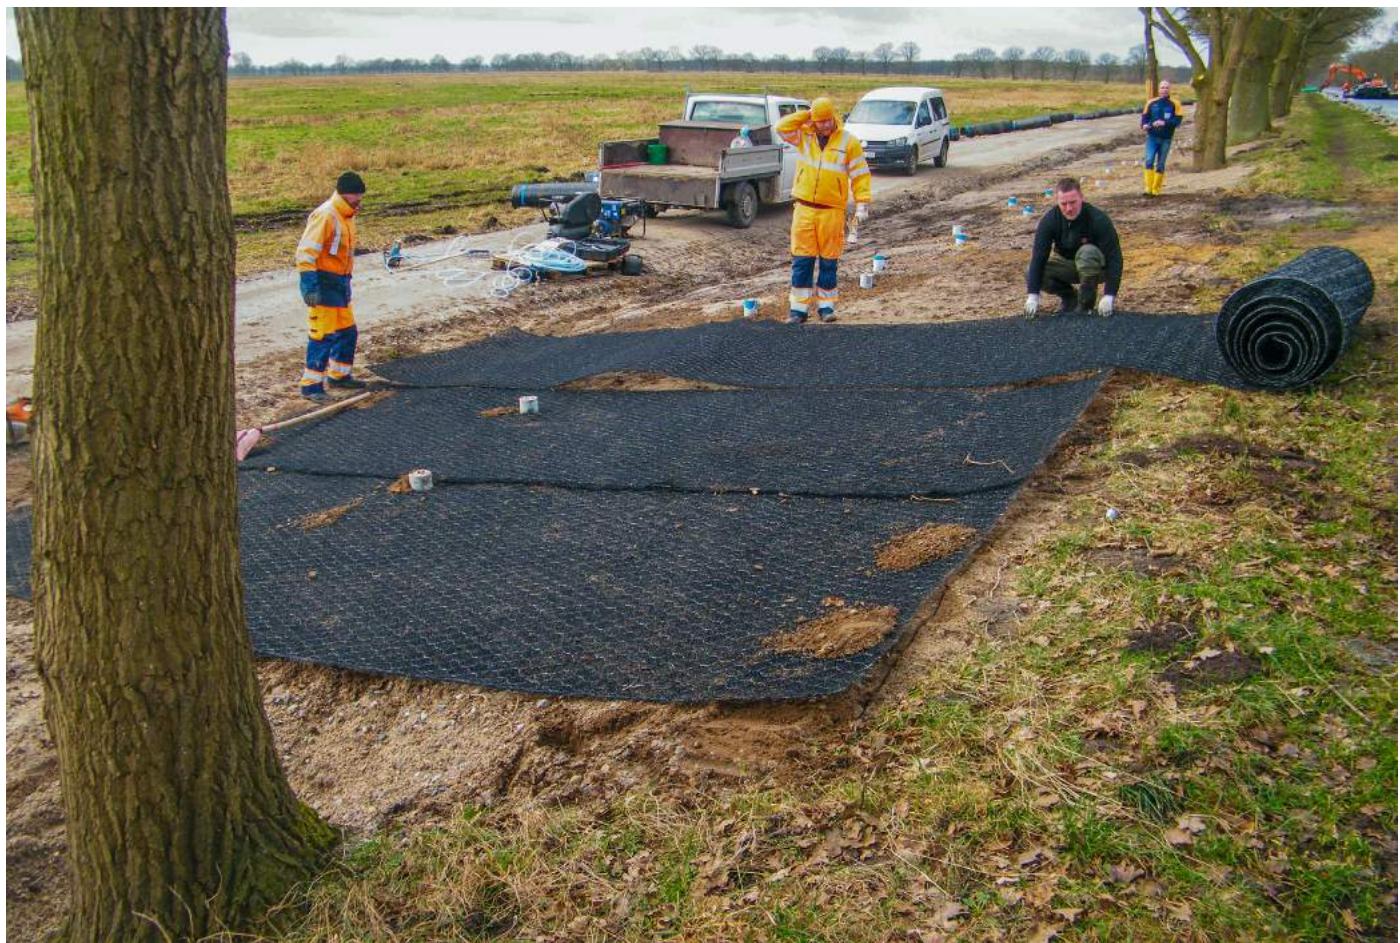
PHOTO Attaching the protective mesh against burrowing animals.

A mesh was laid on top of the ballast filter to protect the dam against rooting animals and the surface was finally covered with an approx. 10 cm thick topsoil layer (humus sand, similar to the existing topsoil). The ventilation pipes were connected to the surface with a layer of gravel 16/32. The installation of the fleece on the pile wall, the addition of missing piles and the installation of the armour stones was carried out from the water side with special equipment on barges. The lane on the dam was levelled

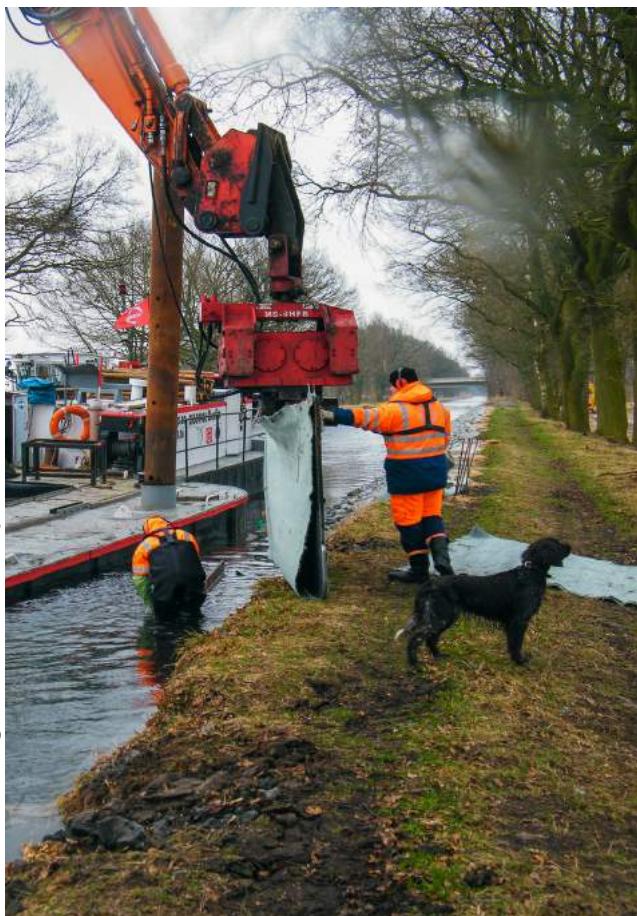
PHOTO Vibrating the fleece with a special device.

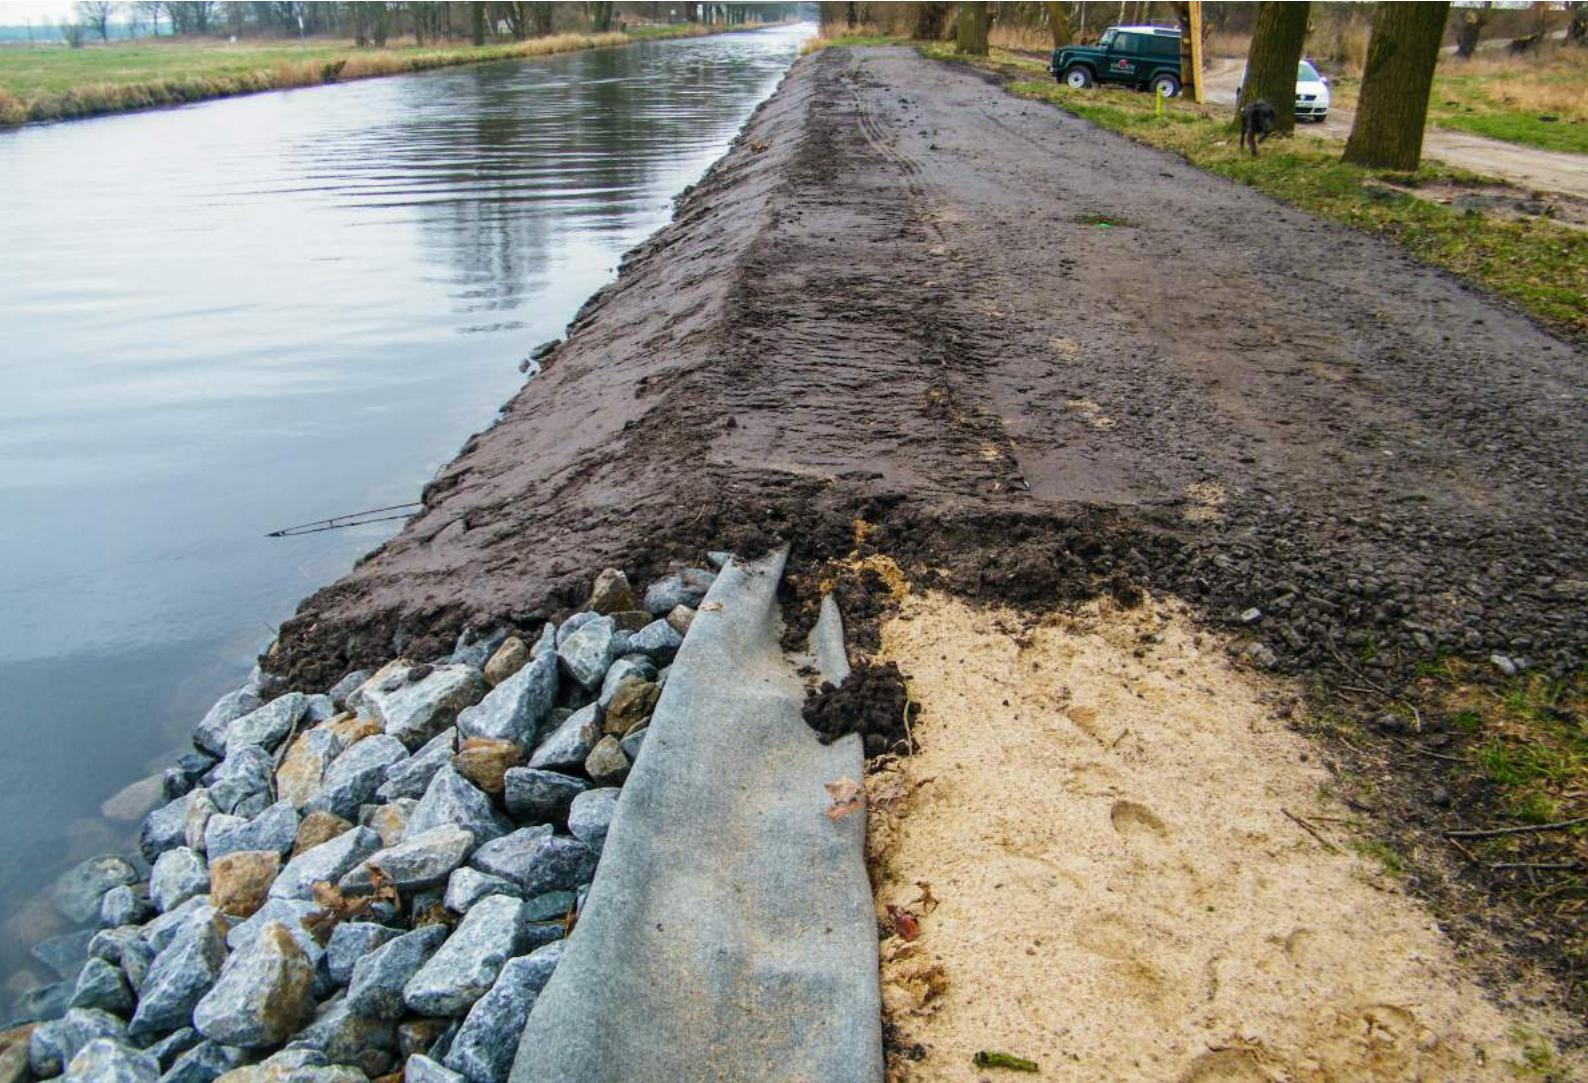
PHOTO Installation of armour stones and covering of the dam crest with humus sand or lean grassland and gravel.

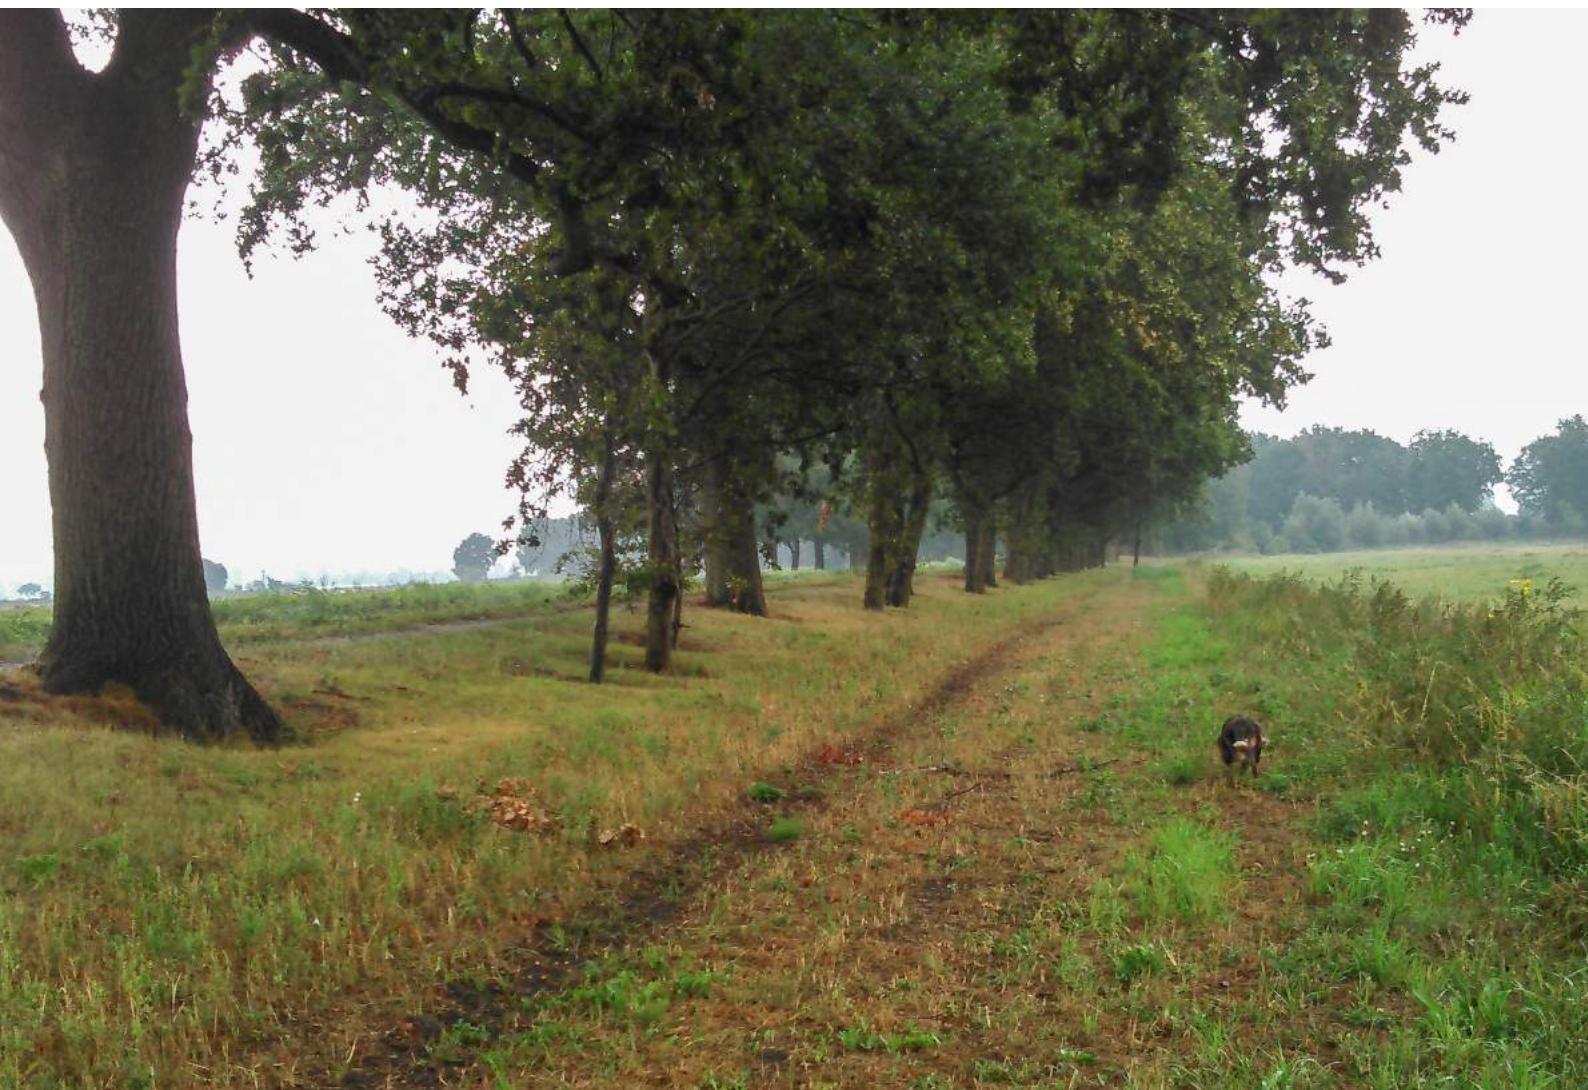
**PHOTO August 2018 - View of the area of the former construction road and the dam stabilised by the side ballast filter with the southern oak row.**

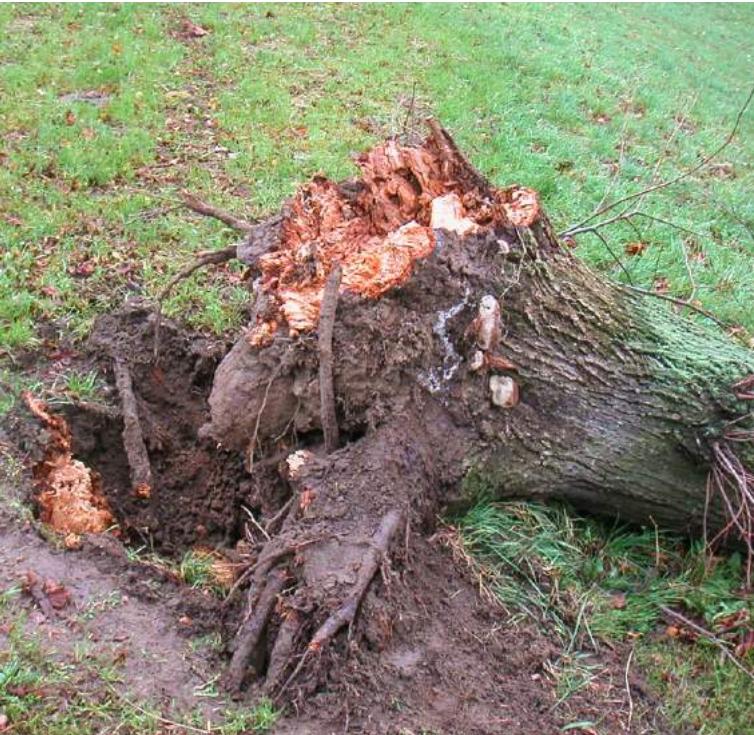
PHOTO The roots have rotted off. Aboveground fungal fruiting bodies are visible.

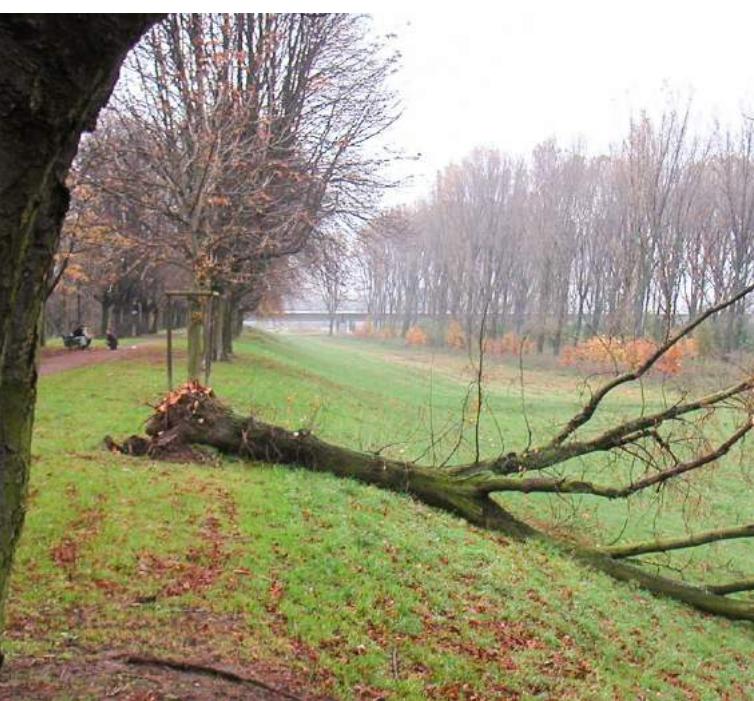
PHOTO Stability failure in the storm due to missing tree control.

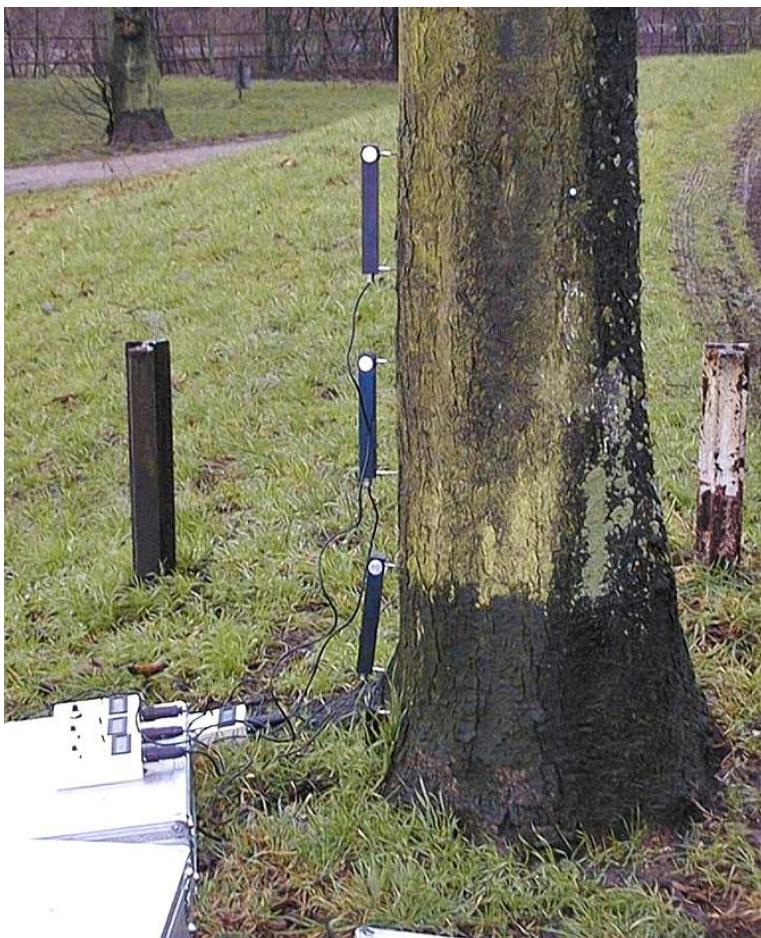
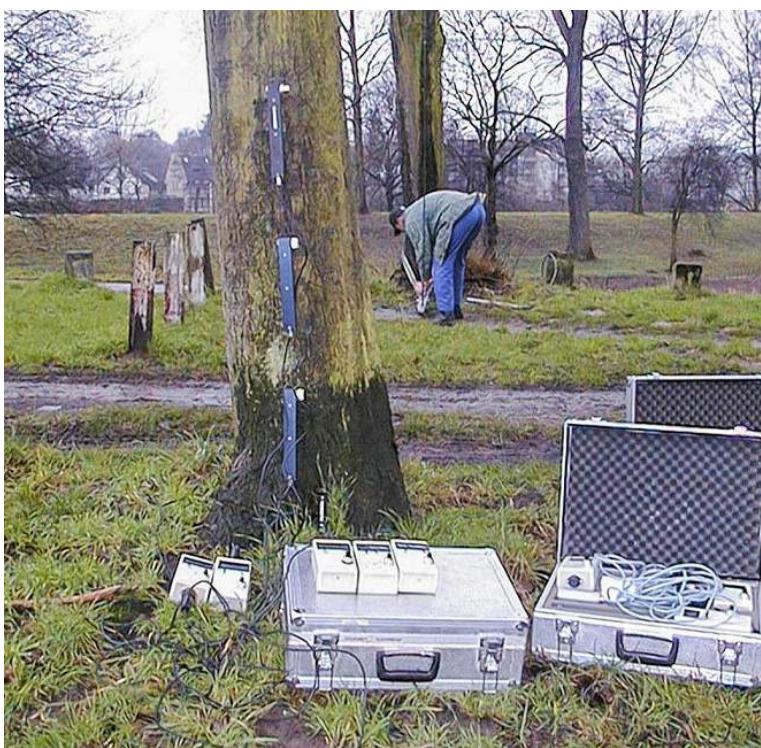
PHOTOS Stability - Inclinometode Injury-free and safe determination of the tipping load (Wessolly 1987).

From the total quantity, 35 trees were selected and examined for a tensile test (SIM: inclino and elastomethode), 15 lime trees and 20 horse chestnuts.

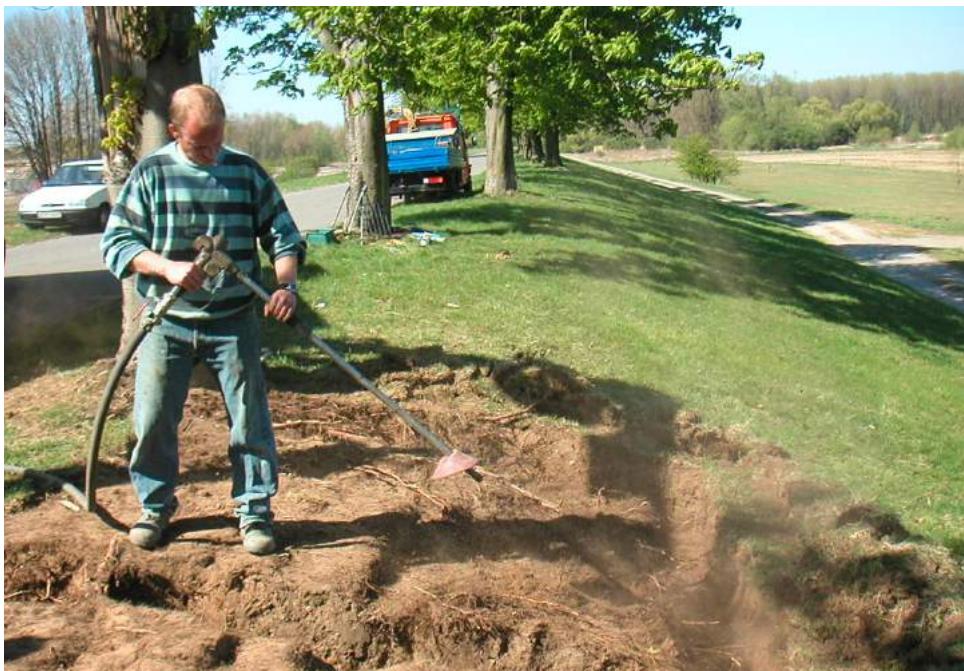
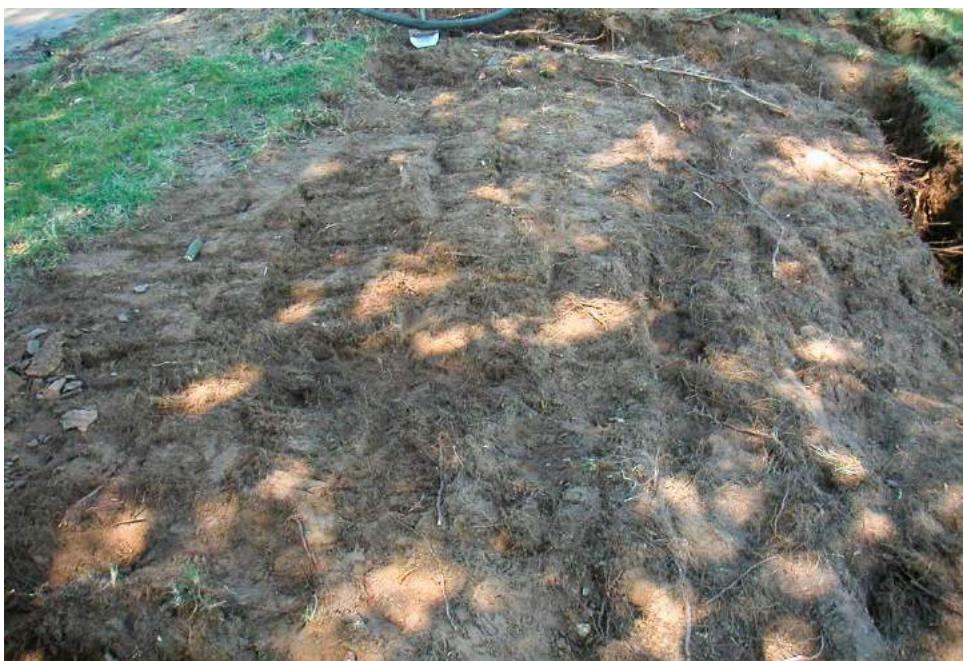
PHOTOS show the dense fine root fleece of the horse chestnut under the grass, through which not even the high-pressure flushing device could penetrate. Like a sack, this fleece holds the soil-sand mixture of the dike together, stabilizes the statics in the event of soaking and prevents rinsing (Wessolly 2002).

The stabilising properties of the fleece could only be stated. On the other hand, the strong roots were measured, their material characteristics investigated and included in the calculation. This has already resulted in a significant improvement in dyke stability.
